INVESTIGATION OF THERMAL FATIGUE IN
NON-TUBULAR REGENERATIVELY COOLED
THRUST CHAMBERS. VOLUME II

AFRPL-TR-73-10
VOLUME II

FINAL REPORT
VOLUME II

ROCKETDYNE DIVISION, ROCKWELL INTERNATIONAL
6633 Canoga Avenue, Canoga Park, California

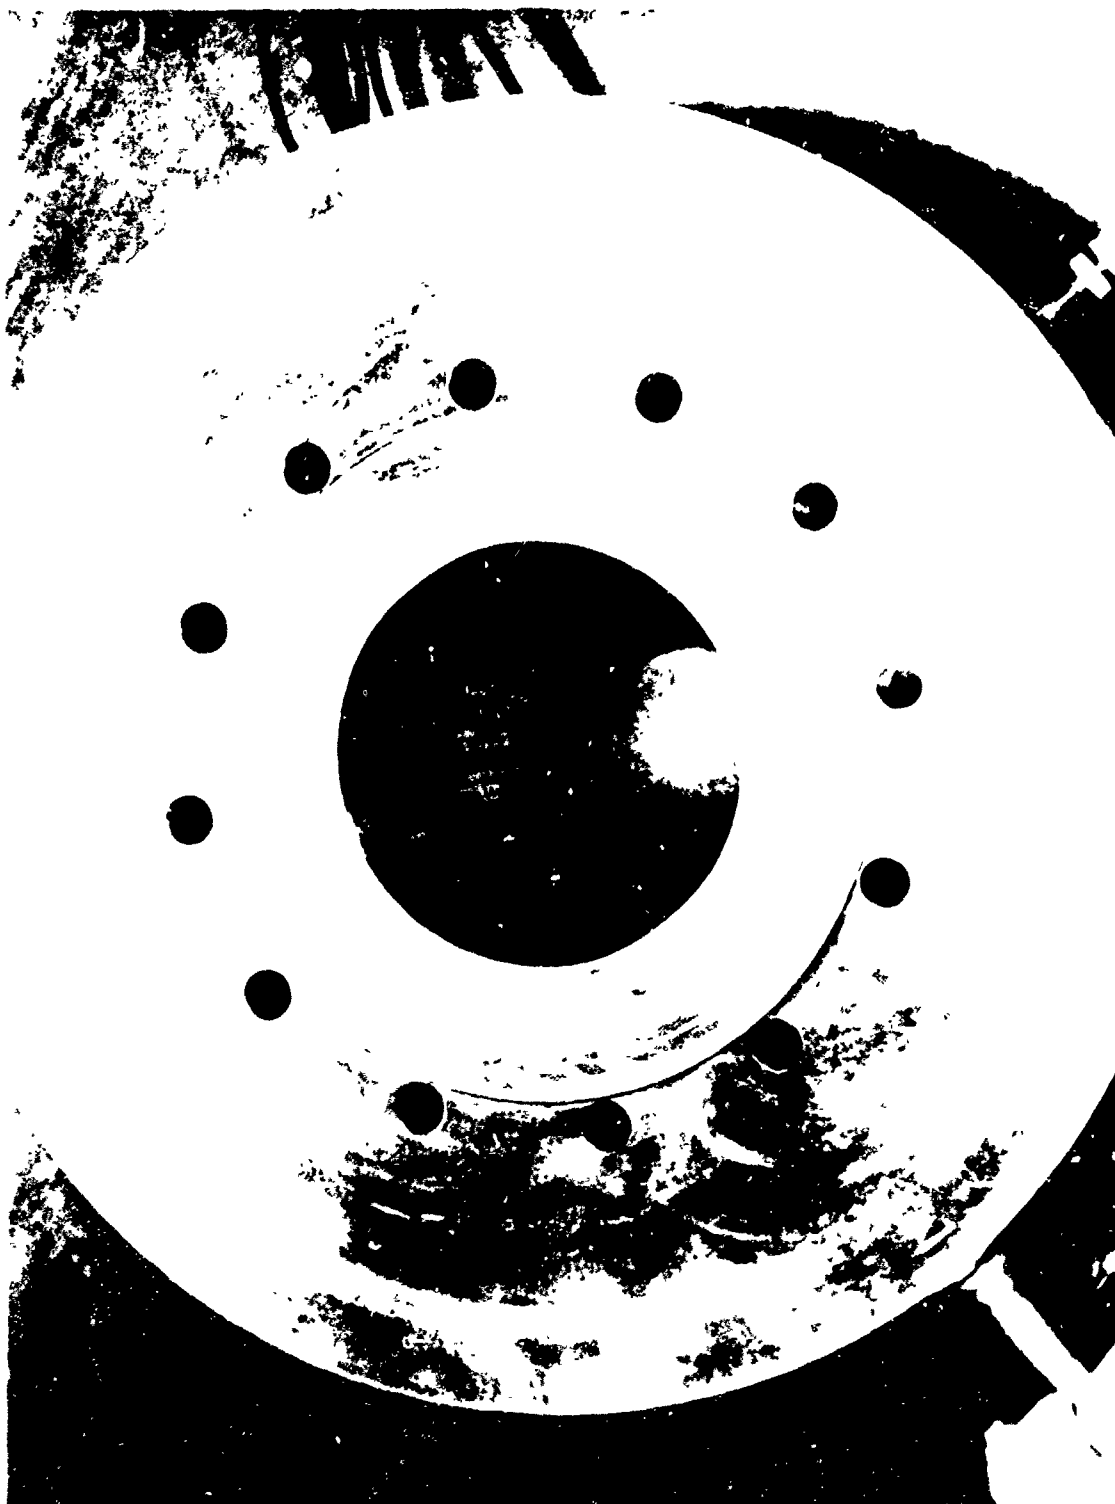
The nickel chamber was then installed on the test stand. A series of checkout tests were run and cyclic tests initiated. After approximately 50 cycles, a facility malfunction again occurred which resulted in destruction of the chamber. The chamber is shown post-test in Fig. 29. Although the cyclic life demonstration was not completed on this chamber, 50 cycles were accumulated prior to the malfunction. There were no thermal cracks on the chamber, indicating that this material can be used for chambers having a reasonably long life requirement.

Figure 29. Nickel-200 Chamber Post-Test

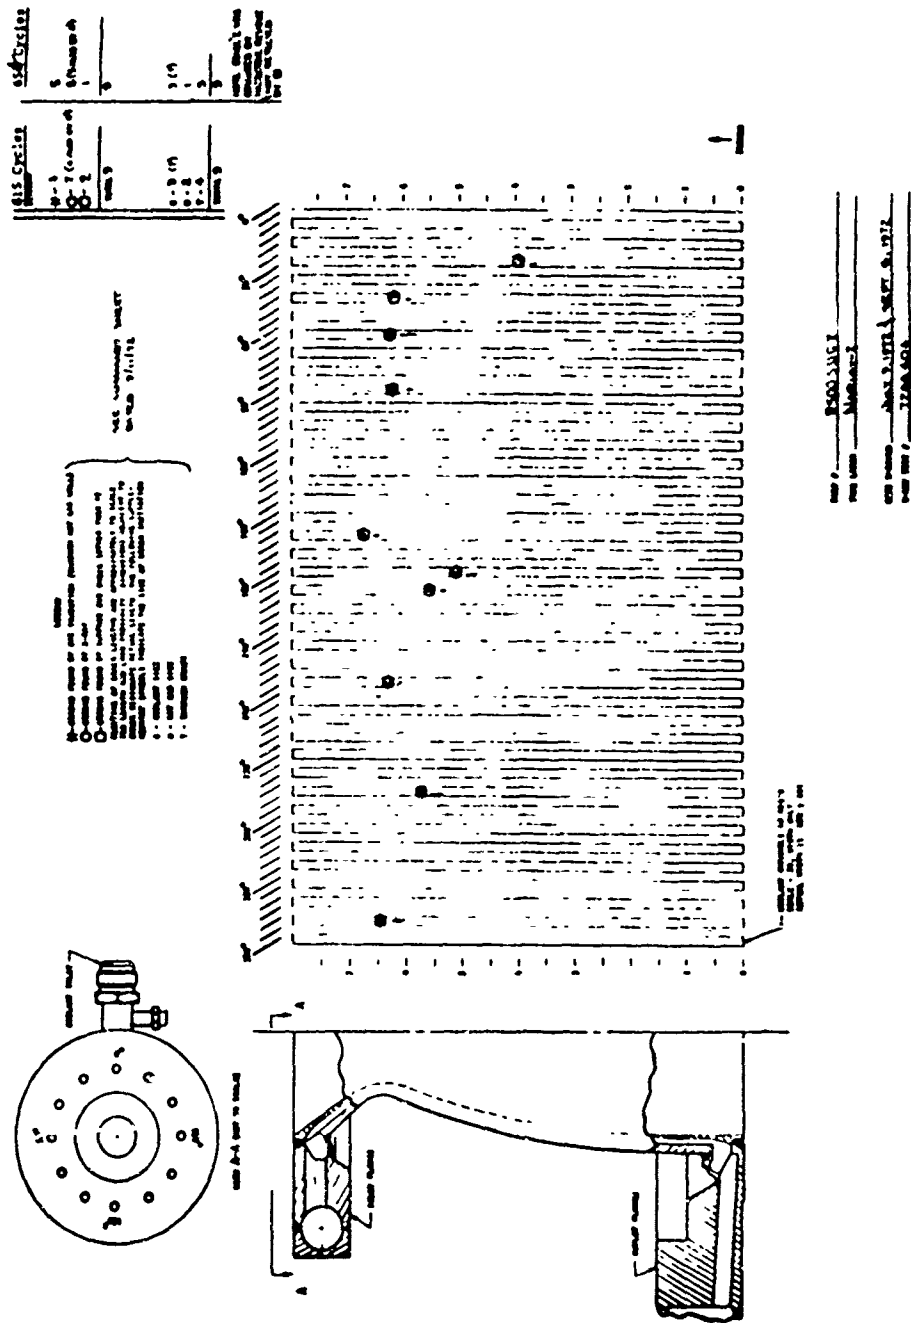
Figure 41. Crack Locations on NARloy-Z Chamber

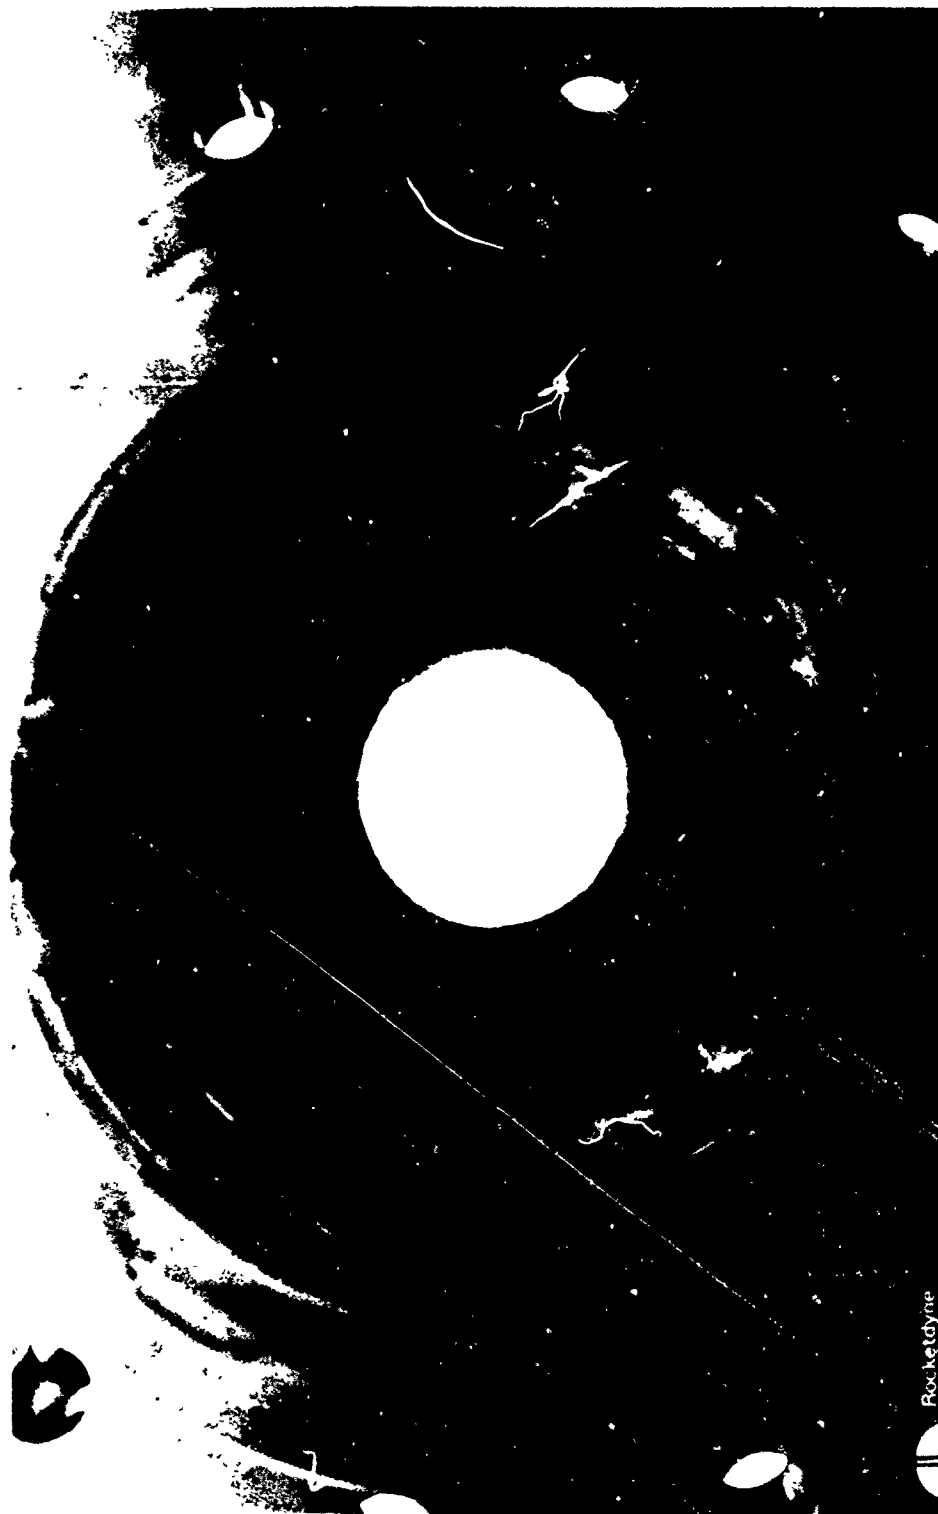
1XW35-7/3/72-C1E*

Figure 47. Overall View Showing Combustion Zone of Zirconium
Copper Chamber After 529 Cycles

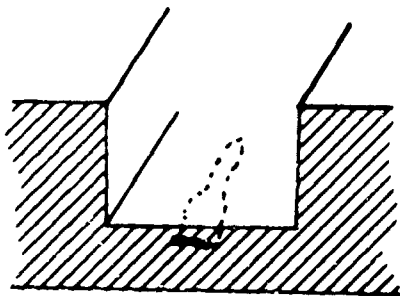
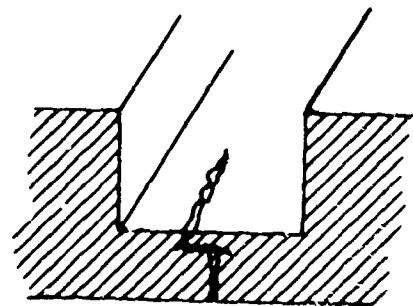
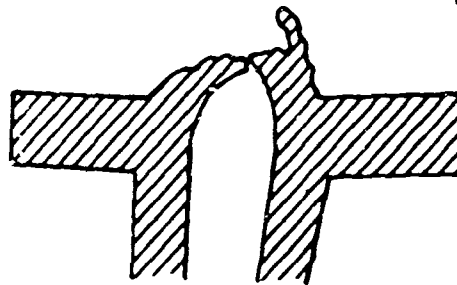
STRINGER IN
ORIGINAL MATERIAL

CRACK PROPAGATION
FROM STRINGER

APPEARANCE AFTER
OPENING BY BENDING

STRINGER INITIATED CRACK EXPOSED BY BENDING
ENTIRE CRACK SURFACE BLACKENED BY HOT GAS

Figure 52. Evolution of a Stringer Crack
